## Power Plant Wilhelmshaven

Deep foundation of cooling water ducts in section C 112 with GEWI-Plus  $\varnothing$  75 mm with single and double corrosion protection combined

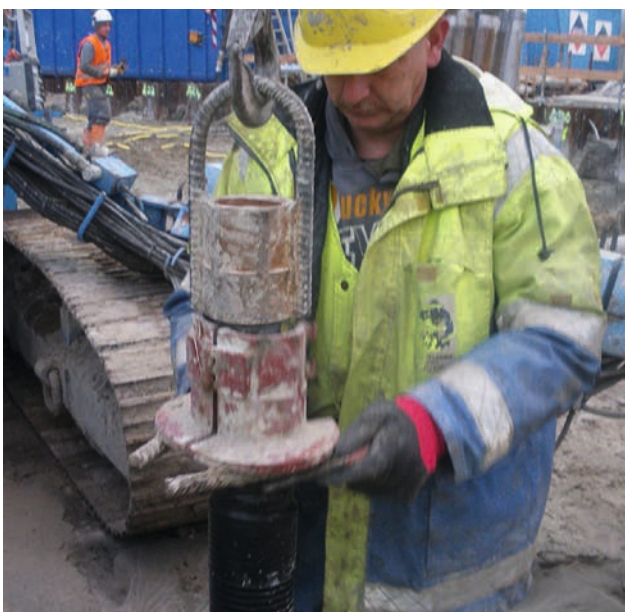
Image 2: Mounting a fold-out muffle to a GEWI-pile

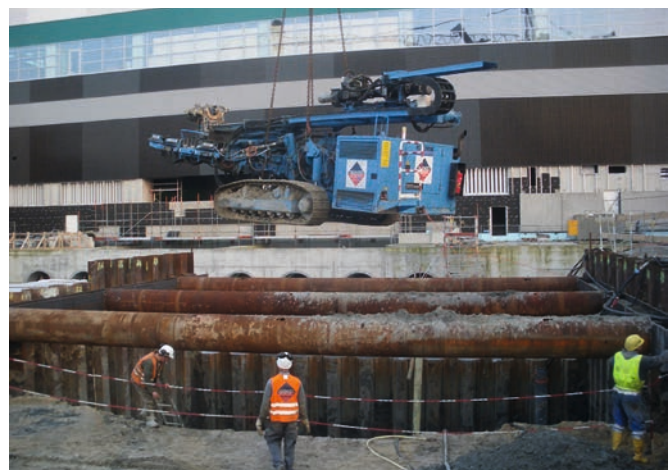
Image 1: Lifting our drill rig onto the work platform
