Bank Wall Southern Zollkanal, Hamburg

Tie-back of a sheetpile wall with micropiles according to DIN EN 14199

System:	TITAN-Micropile / type 103/51
Quantity:	64 pcs.
Length:	23,00 – 29,00 m / inclined at 43° – 59° toward horizontal axis
Service Load:	up to 1500 kN
Technique:	rotary percussive flush drilling
Building Ground:	Sand
Time Frame of Works:	29. March - 19. April 2010

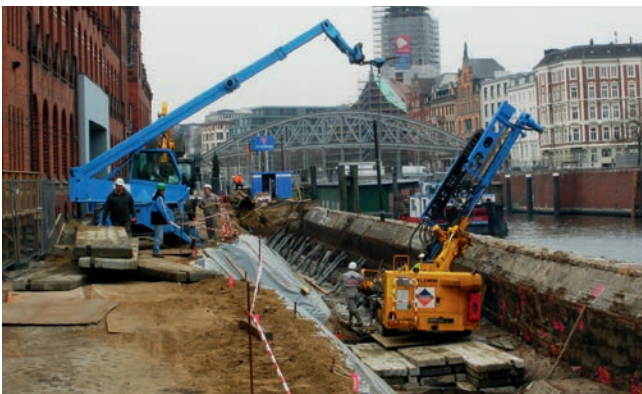
Image 2

wood piles, on top of which the historic warehouses have been founded. In order to comply with this requirement, we prompted the crafting of steel stencils according to the information provided by the surveyor, with which we were able to stay exactly on the intended bore path. And as it turned out, we indeed did not harm any of the historic deep foundations whatsoever. Images 2 and 3 exemplify our drill works in the heart of the HafenCity with our own lifting equipment load a 3 m long steel casing onto the drill mast of our bore unit.

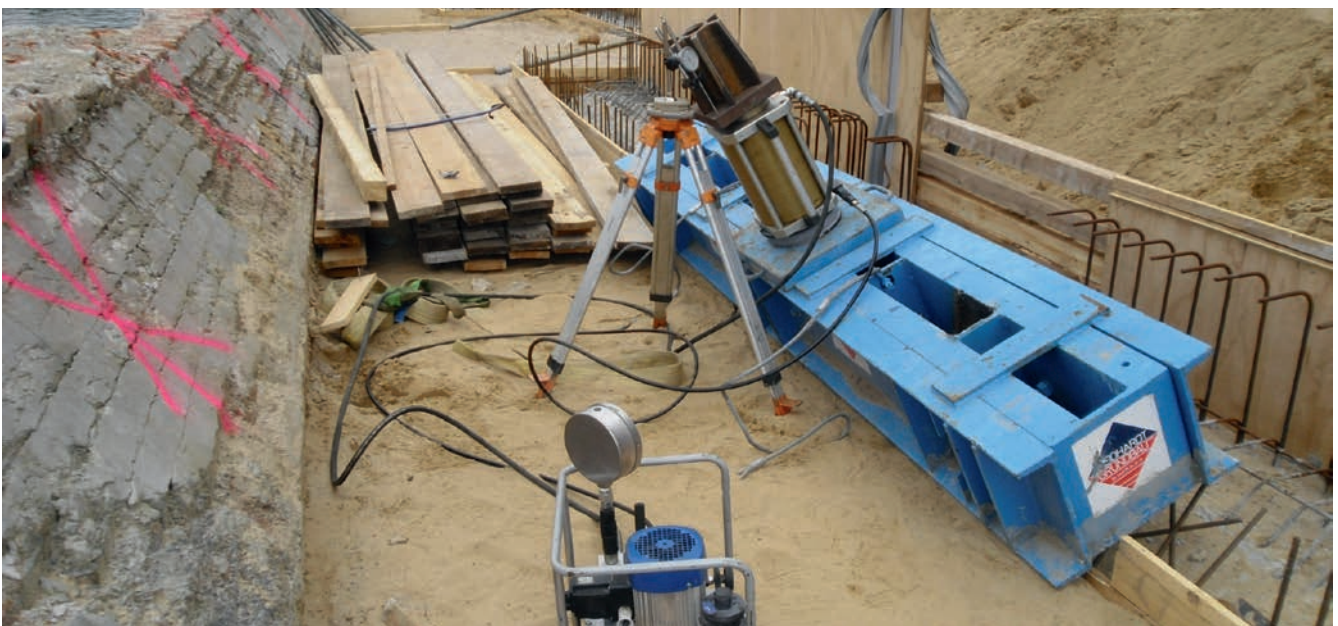
Image 4

After completion of the reinforced waling and after sufficient time for hardening, every one of our TITAN-micropiles underwent an acceptance test. As a result, we were able to prove that no deficiencies or otherwise abnormal properties related to withstanding the test loads of up to 1900 kN could be observed. Thus, all of our TITAN-micropiles were able to carry out their structural design function to the full extent and we were able to make yet another building project "ground-proof" (see Image 4)
